**CLEANING STUDY OF GENESIS SAMPLE 60487.** K. R. Kuhlman<sup>1</sup>, M. C. Rodriguez<sup>2</sup>, C. P. Gonzalez<sup>2</sup>, J. H. Allton<sup>2</sup>, D. S. Burnett<sup>3</sup>; <sup>1</sup>Planetary Science Institute, 1700 East Fort Lowell, Suite 106, Tucson, AZ 85719; [kim@psi.edu](mailto:kim@psi.edu), <sup>2</sup>NASA/Johnson Space Center, Houston, TX 77058; <sup>3</sup>California Institute of Technology, Pasadena, CA.

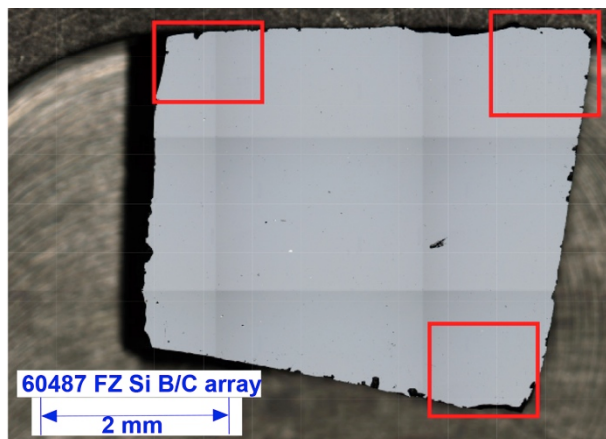
We have conducted a correlative microscopic study of the efficacy of cleaning Genesis samples with megasonically activated ultrapure water [1] and UV/ozone cleaning [2]. Sample 60487, the study sample, is a piece of float-zone silicon from the B/C array approximately 4.995mm x 4.145 mm in size (Figure 1).

Figure 1. 5X Optical image of Genesis sample 60487 with regions scanned at higher resolution indicated. The region analyzed in this study is at Position 1, the upper left hand corner of the sample.

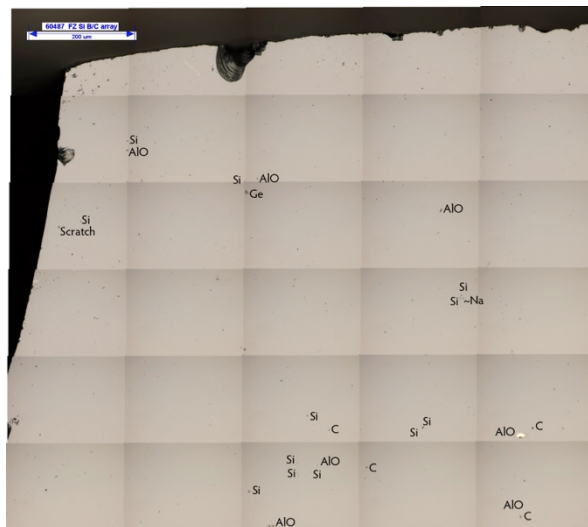
Figure 2. 50X Optical micrograph consisting of multiple high-resolution images of sample 60487. Particles that could be analyzed with low energy EDX are indicated.

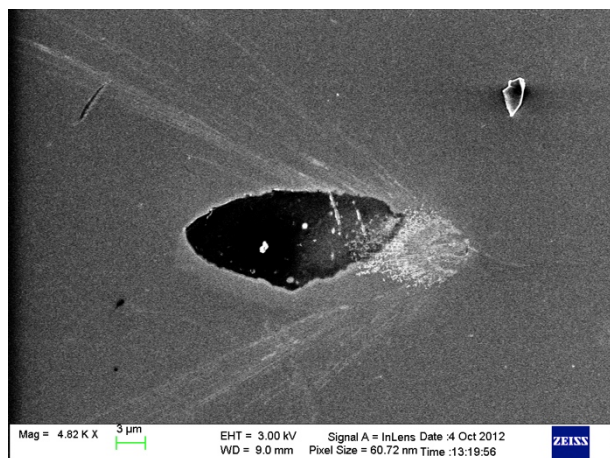
One set of particles of interest are the white ovals seen in both the 5X and 50X optical images. Qualitative EDX indicated that these particles are composed of Al and O that appears to have wetted the sample upon deposition (Figure 3). The source of the Al and O is still unknown.

Figure 3. Al and O contamination of surface of 60487. The impact-like feature is unexplained as it does not occur with other particles of Al and O on this sample.

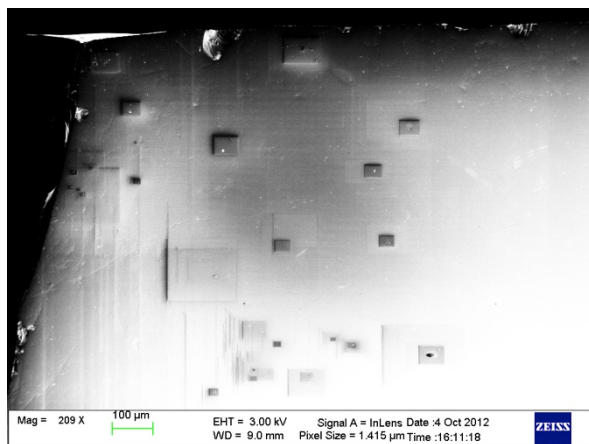
During imaging and analysis of the particles, the electron beam deposited a fair amount of hydrocarbons on the surface of the sample (Figure 4).

Figure 4. In-lens image of 60487 after SEM and EDX analysis. Note the distinct rectangles of hydrocarbons deposited by the electron beam during imaging and analysis.

**UV/Ozone cleaning.** Sample 60487 was returned to NASA JSC for UV/O<sub>3</sub> cleaning [2] to check the efficacy of this technique to remove the hydrocarbons deposited by the SEM during imaging and analysis. It was exposed to UV/O<sub>3</sub> for 30 min.

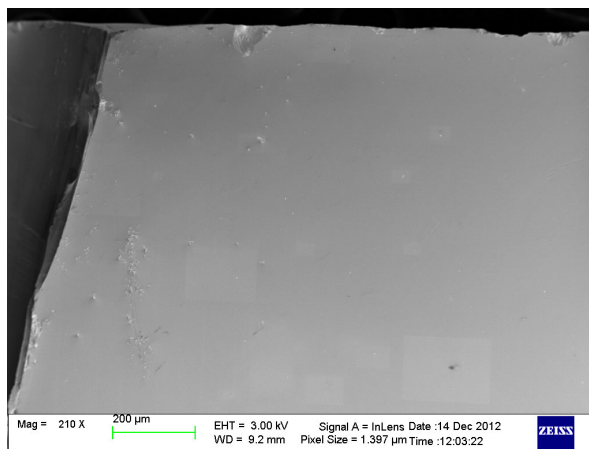
**SEM study of remaining residue.** Sample 60487 was returned to the Univ. of Wisconsin for further SEM study. A series of SEM images was quickly taken to avoid adding more hydrocarbons to the sample. One of these images from the in-lens detector is shown in Figure 5. While subtle, the rectangles made during the first SEM analysis are still visible, indicating that the UV/O<sub>3</sub> cleaning was only partially effective.

Figure 5. In-lens micrograph of 60487 after UV/O<sub>3</sub> cleaning. The rectangular boxes deposited by the electron beam during the first SEM analysis are more subtle, but can still be seen using the in-lens detector.
